## CONCRETE SOLUTION

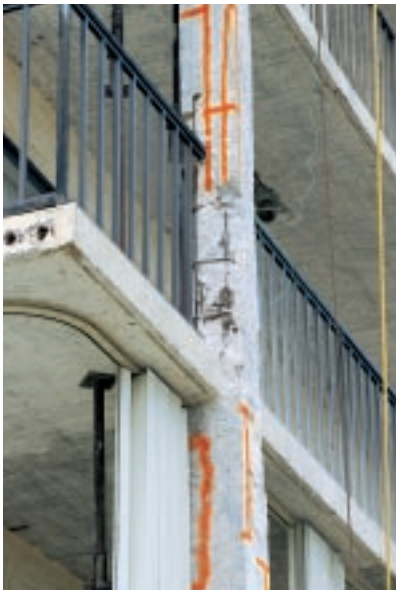
*Salty sea breezes create spalling on Florida's concrete balconies. The salt migrates down to the steel reinforcing bars, rusting the bars and cracking the concrete. The edges and surfaces get unsightly and structural damage occurs in support columns.*

Indeed, the aging oceanfront condominium market, as well as seaside commercial buildings, are in constant need of upkeep and restoration. The steel reinforcement bars—called rebars—that are embedded in concrete patio floors of beachside condo units have been particularly hard hit. Cracks and splitting of the concrete are major headaches. Cracks allow more water, more salt, and more acid to enter. Penetration accelerates, causing larger cracks and spalling. This troublesome material malady hits many concrete structures with decks that face the beach. Balconies in Florida have been deteriorating at a rapid pace.

Emory explains that concrete, due to aging and other factors, loses its pH, or acidity value. Poured concrete has a high pH value of 11, 12, or 13. That high value can inhibit corrosion. The aging of the concrete is a natural process in which the pH starts to drop. When the pH value dips into the 8 to 9 range, there is potential for corrosion of the reinforcing bars, he points out.

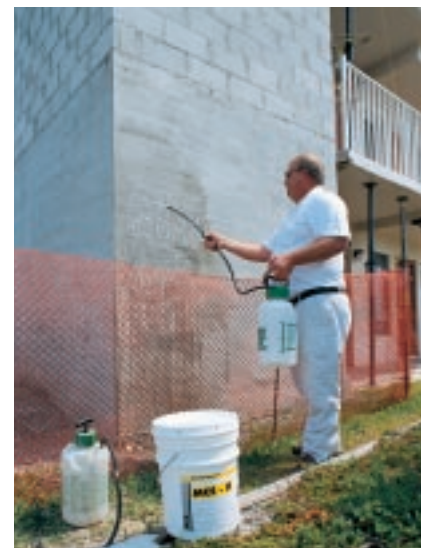
*The cracked (spalled) concrete must be chipped away and replaced. The Surtreat chemical is sprayed on the concrete and exposed steel bars.*

option to fight structural corrosion. Surtreat's GPHP product is applied to the surface of a corroding concrete slab and then seeps through to the rebar, coating it and preventing further corrosion.
